# ARBORIST REPORT AND TREE PROTECTION PLAN

**CA-7286**  
**5017 Terrace Ave.**  
**Lakeport, CA**

**December 2023**

Arborist Report & Tree Protection Plan for  
5017 Terrace Ave. (CA-7286)  
Lakeport, CA

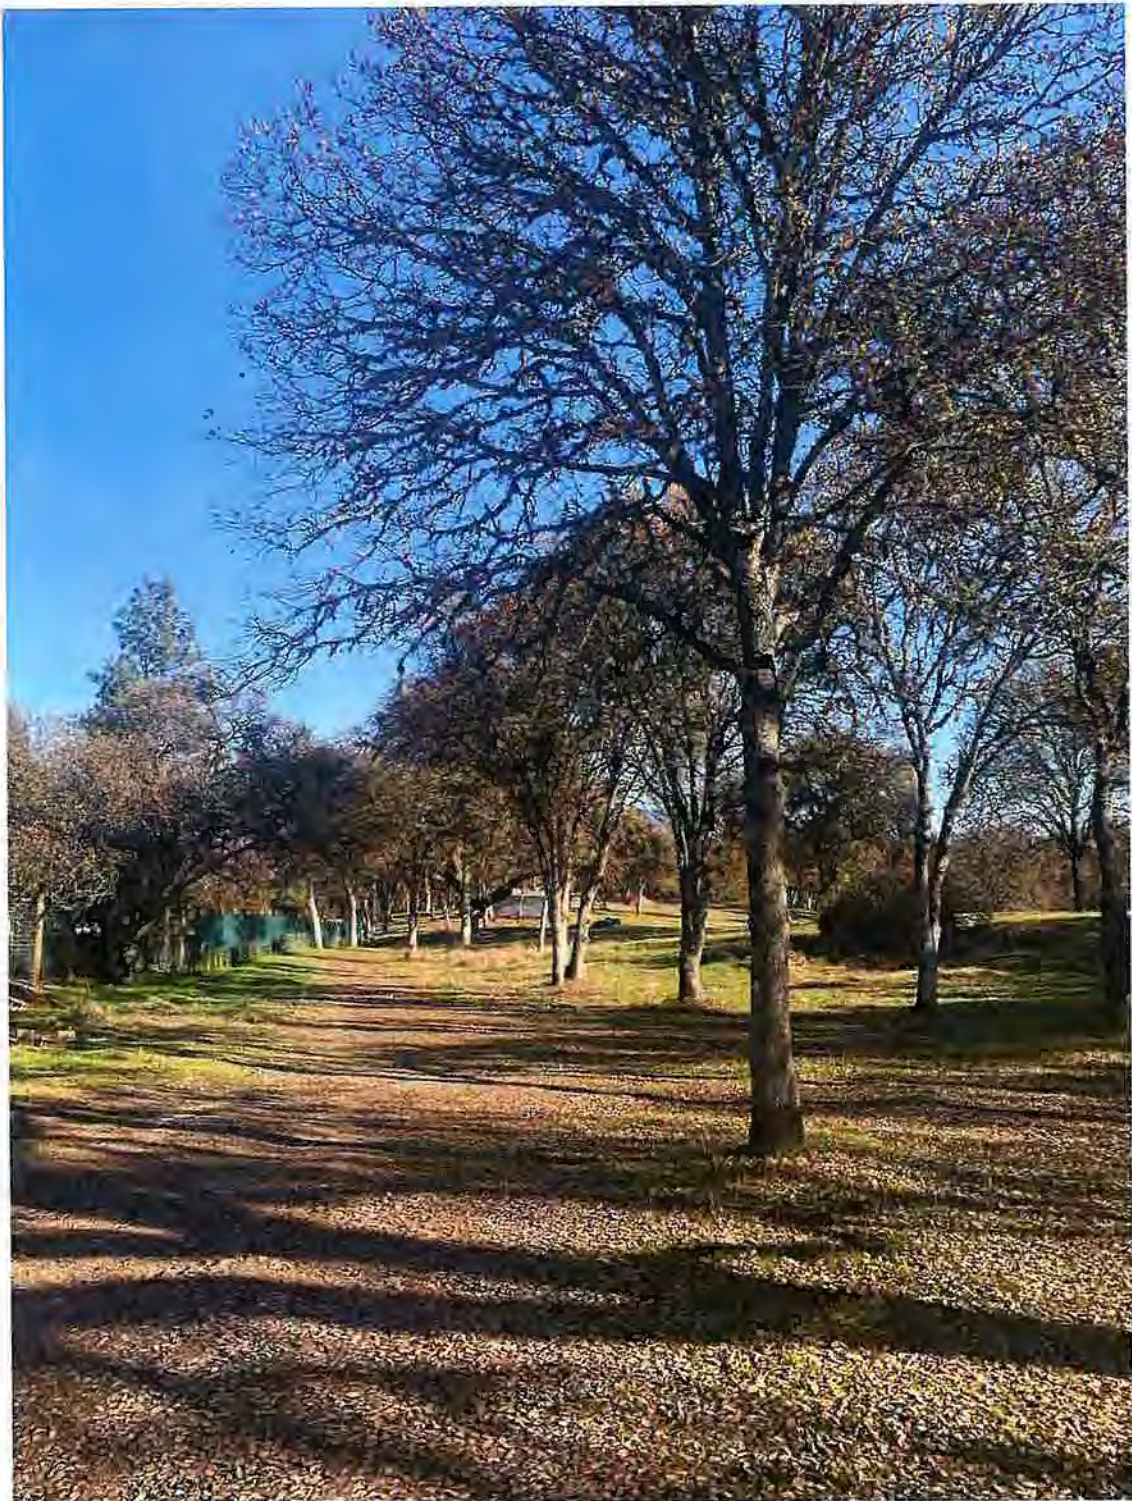
Photo 1. Several oaks adjacent to the existing unimproved access road. Tree #25 (foreground)

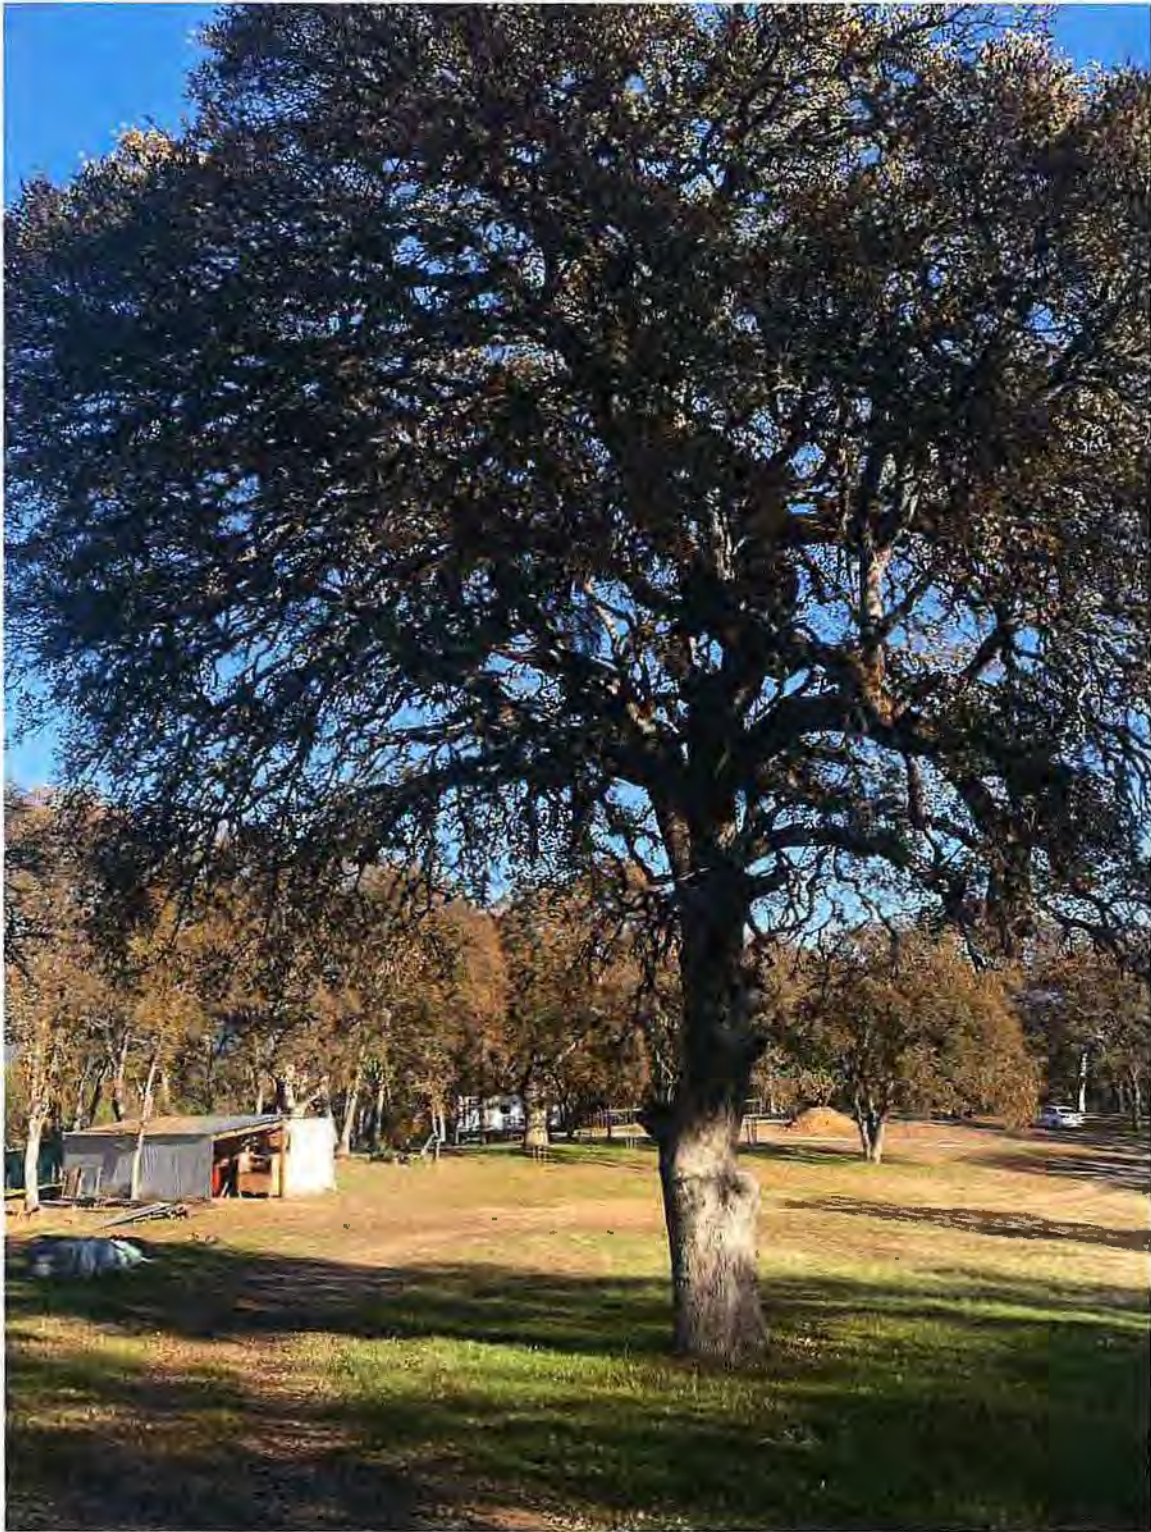
| Tree # | DBH (in, sum) | Common Name | Preservation Priority | Protected Tree (Y/N) | Proposed Removal (Y/N) | Notes |
|---|---|---|---|---|---|---|
| 31 | 33 | Blue oak | 1 | Y | N | Prev. failures, ~10' from existing road |

**Photo 2. Tree #31 is 10 feet from existing path and proposed gravel road. Tree protection measures outlined in this report shall be followed to minimize impacts from compaction within the TPZ and potential compaction within the SRZ.**

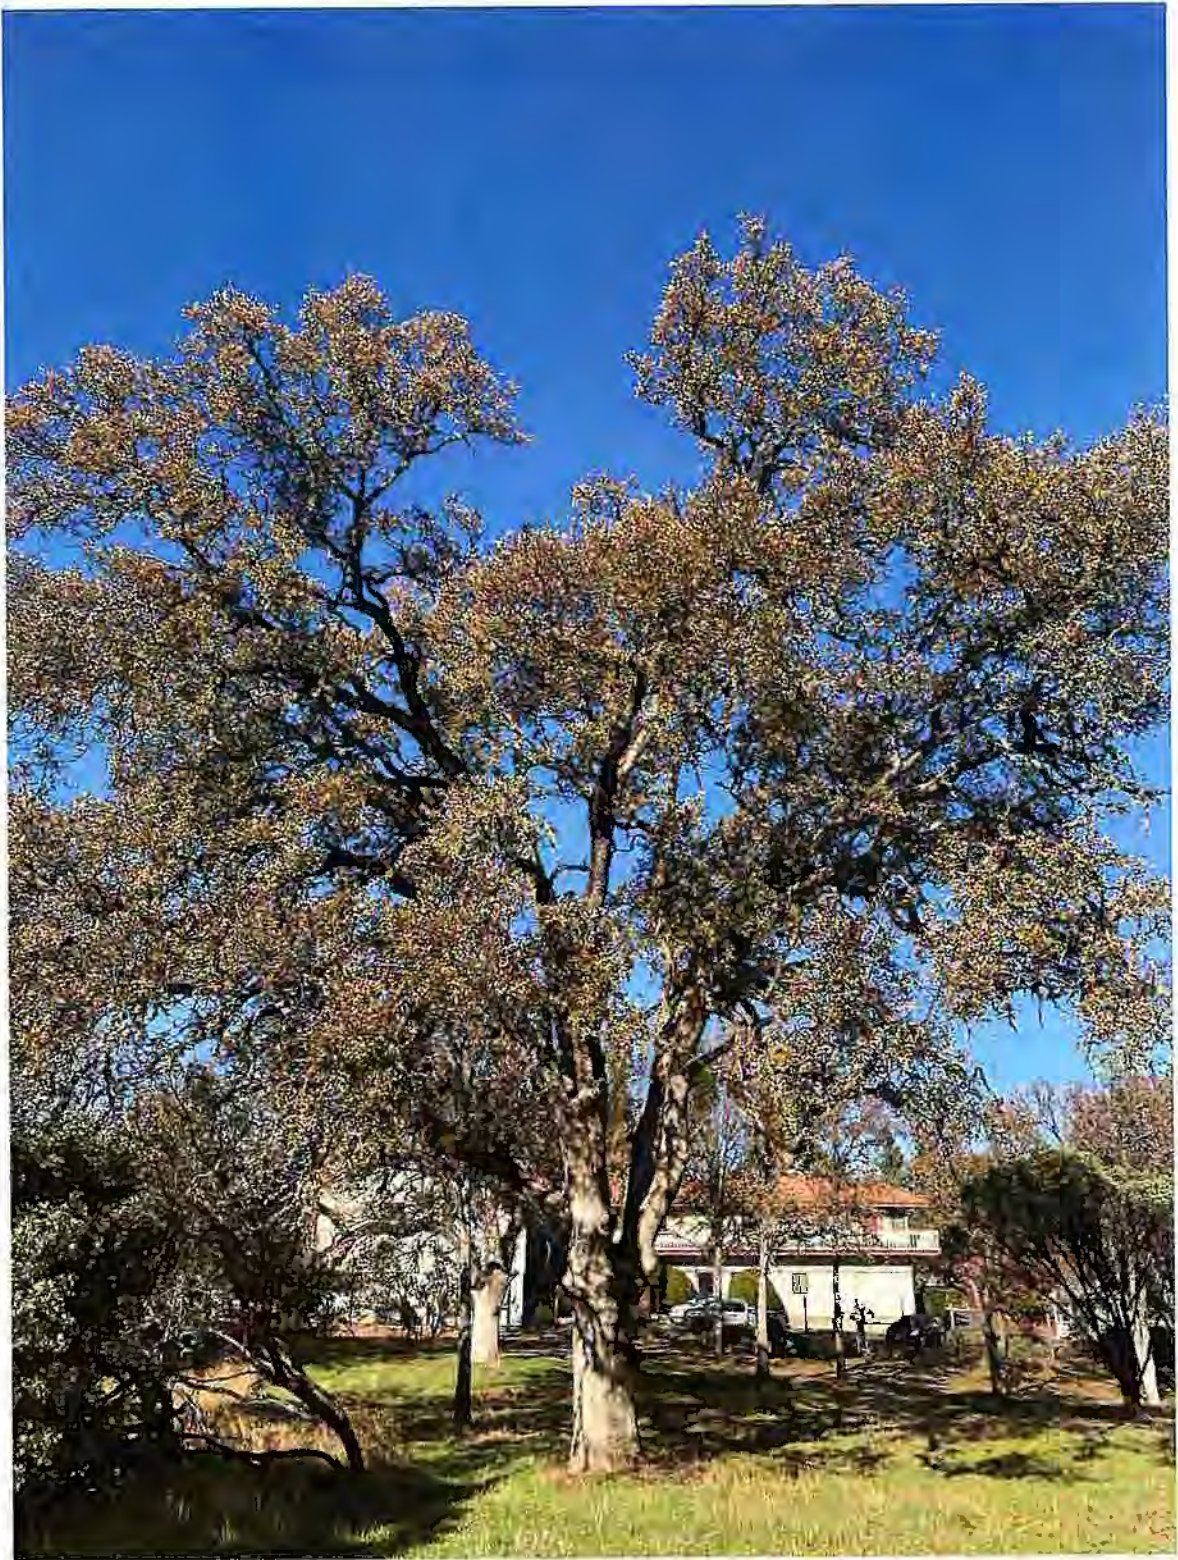
**Photo 3. Tree #19 is a large blue oak in fair condition and is not expected to be impacted by construction.**

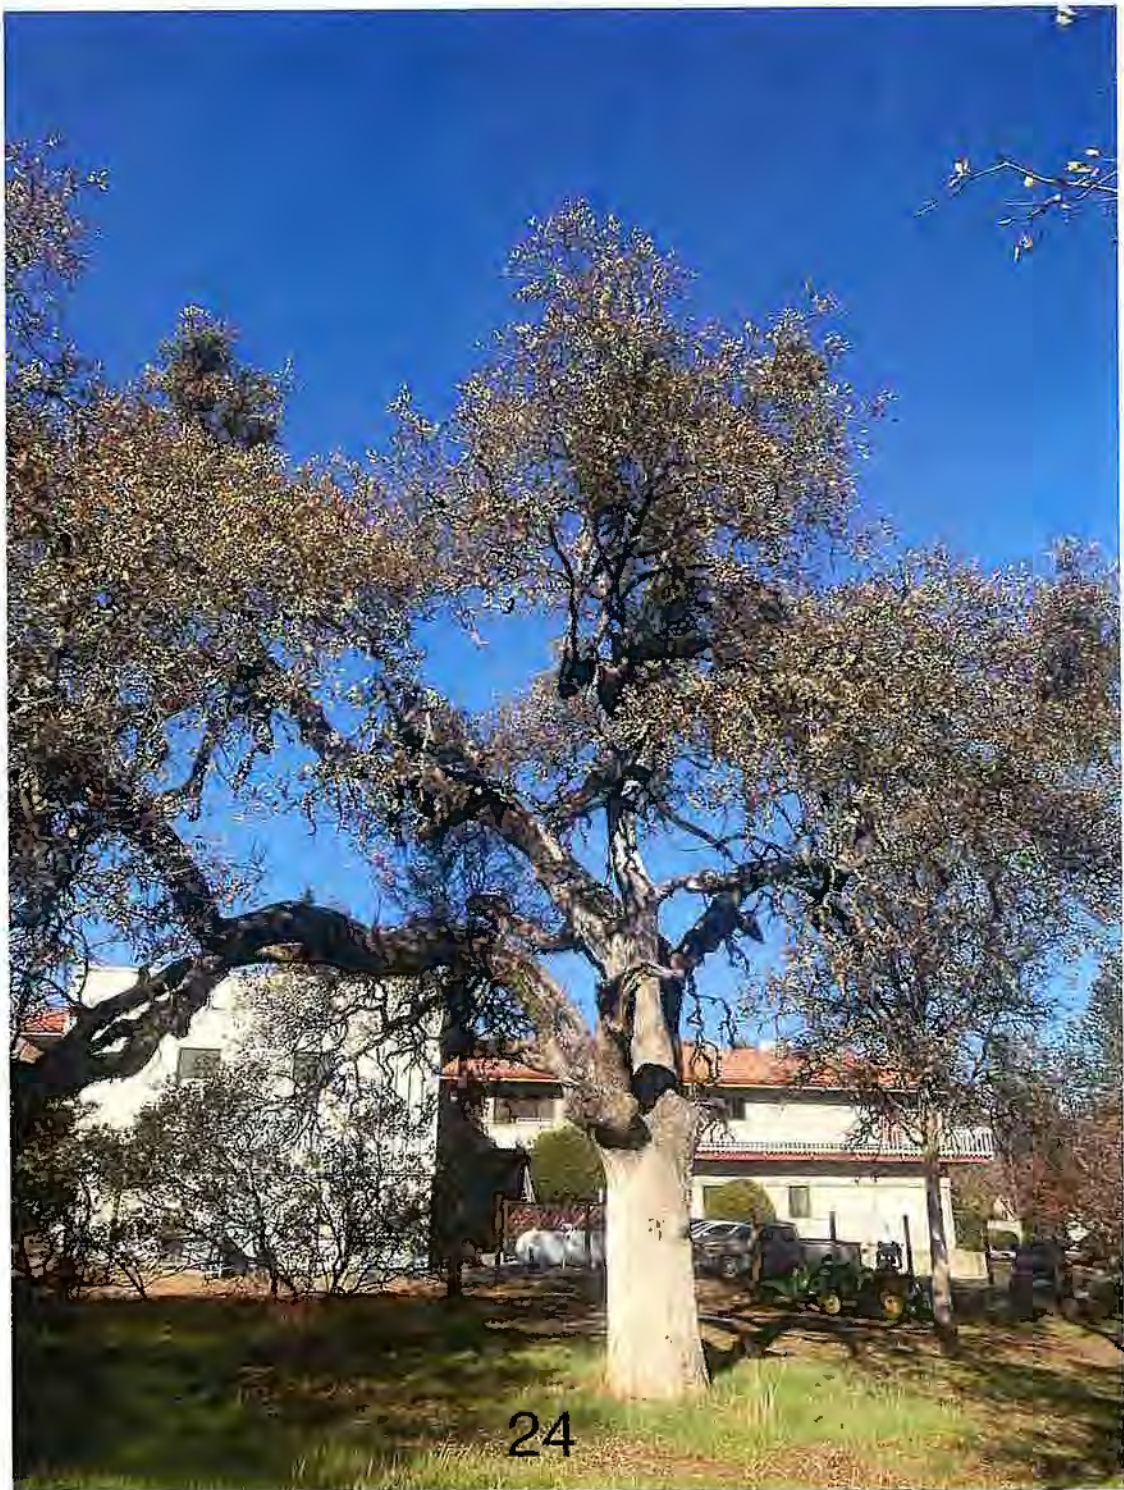
| Tree # | DBH (in, sum) | Common Name | Preservation Priority | Protected Tree (Y/N) | Proposed Removal (Y/N) | Notes |
|---|---|---|---|---|---|---|
| 24 | 32 | Blue oak | 1 | Y | N | Prev. failures, d/w > 4" |

**Photo 4. Tree #24 had previous large branch failures and is listed as in fair condition. This tree is near proposed road construction (drawing A2 from site plan) and will need tree protection if construction occurs within the TPZ.**

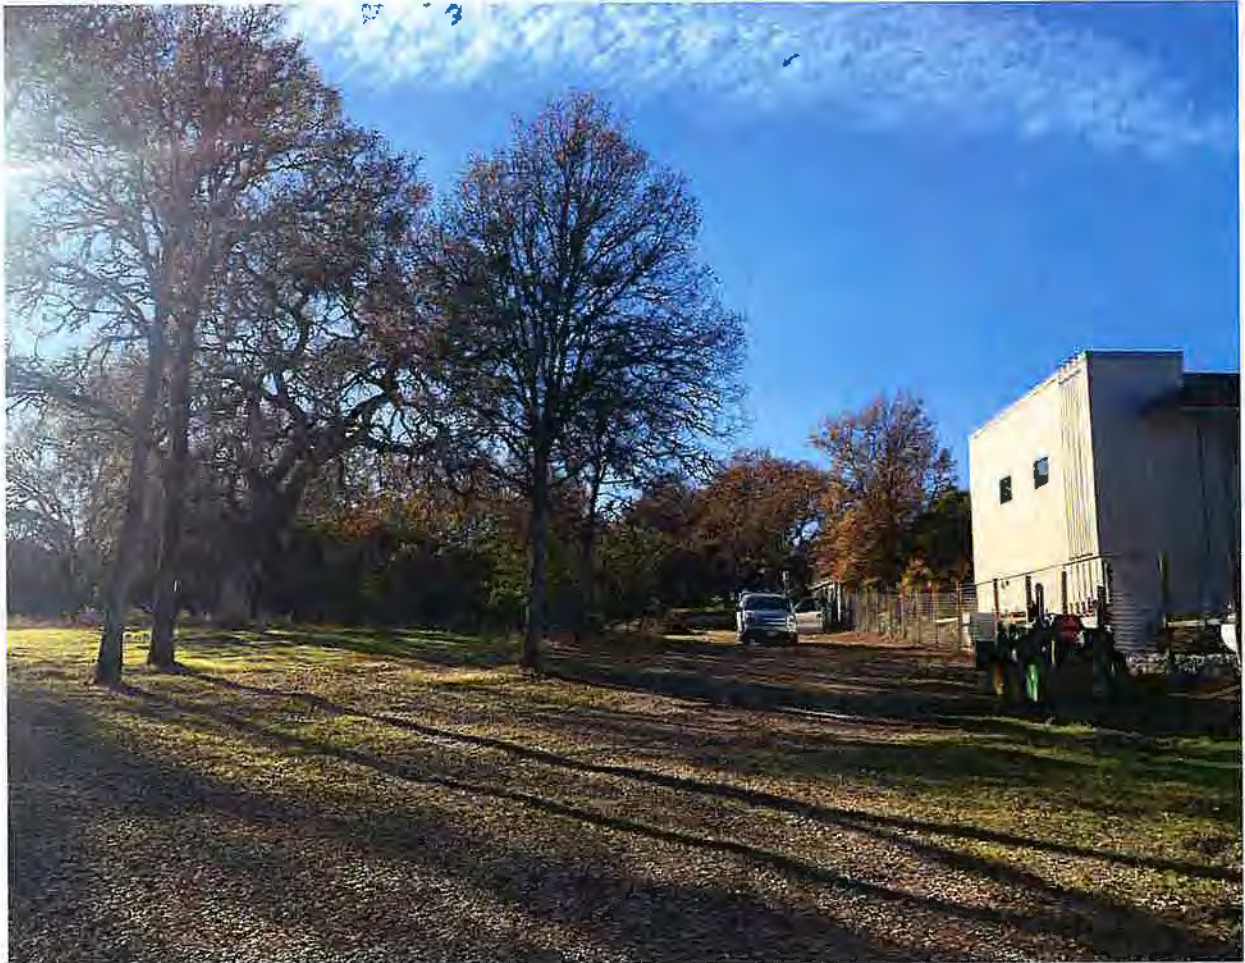
**Photo 5. Another view (west) with trees #43, #44 and #29 pictured near existing and proposed road construction. TPZ and 5RZ impacts are expected.**

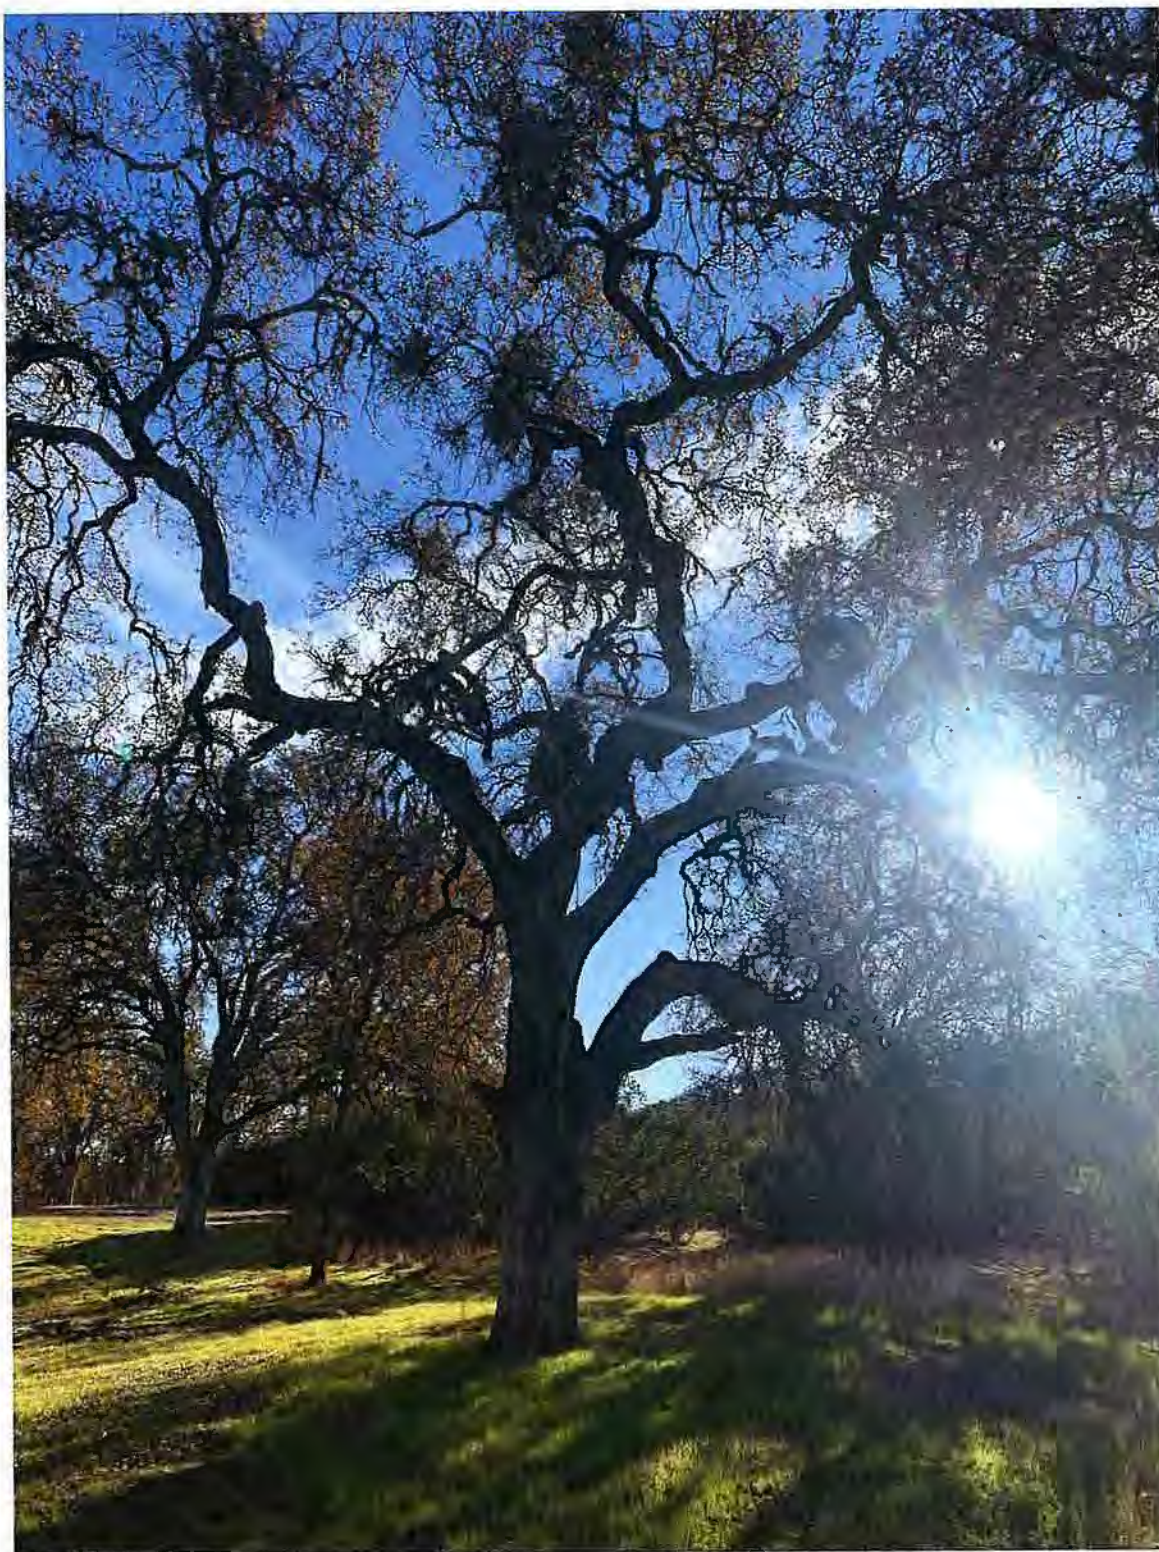
**Photo 6. Another angle of tree #24. Deadwood over 2" diameter should be trimmed and removed.**

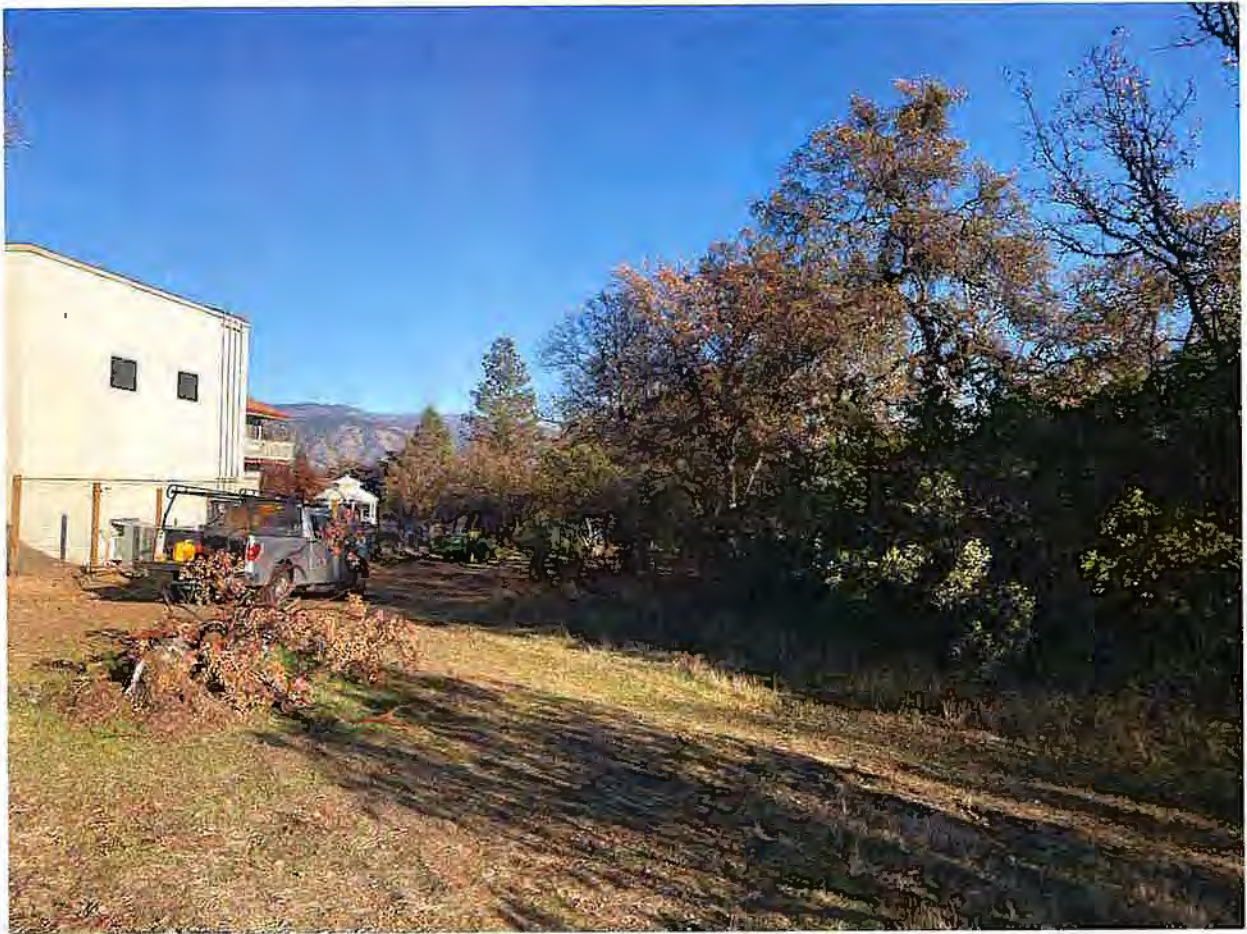
**Photo 7. Area of proposed fenced compound lease area adjacent to trees #26-#28. Any construction within the TPZ of these trees must follow tree protection measures.**

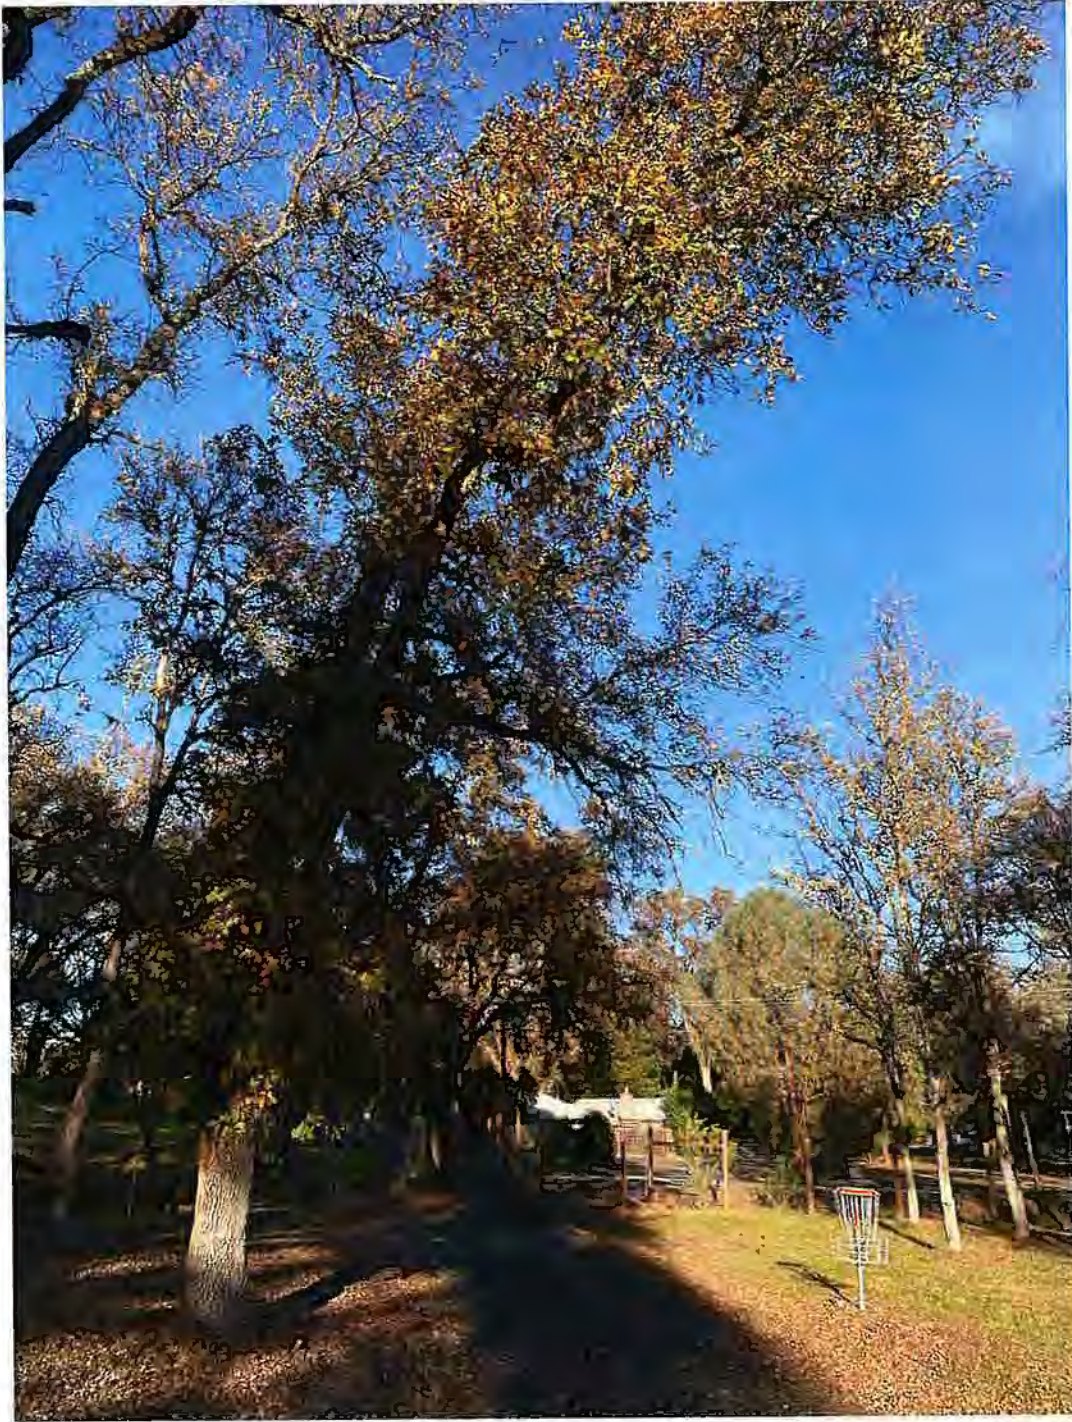
| Tree # | DBH (in, sum) | Common Name | Preservation Priority | Protected Tree (Y/N) | Proposed Removal (Y/N) | Notes |
|---|---|---|---|---|---|---|
| 50 | 15 | Valley oak | 2 | Y | N | slight lean over road |

**Photo 8. Tree #50 is leaning over the road near the entrance to the property. Impacts within the TPZ and SRZ from road construction are expected.**
